CHARACTERIZATION OF NATURAL STONES EMPLOYED IN HISTORICAL BUILDINGS: A CASE STUDY OF THE FORT IKOMA HISTORICAL BUILDING IN SERENGETI NATIONAL PARK, TANZANIA

Rajab Ayubu Chuo^{1*},², Patrice Nyangi¹, and Gislar Kifanyi¹

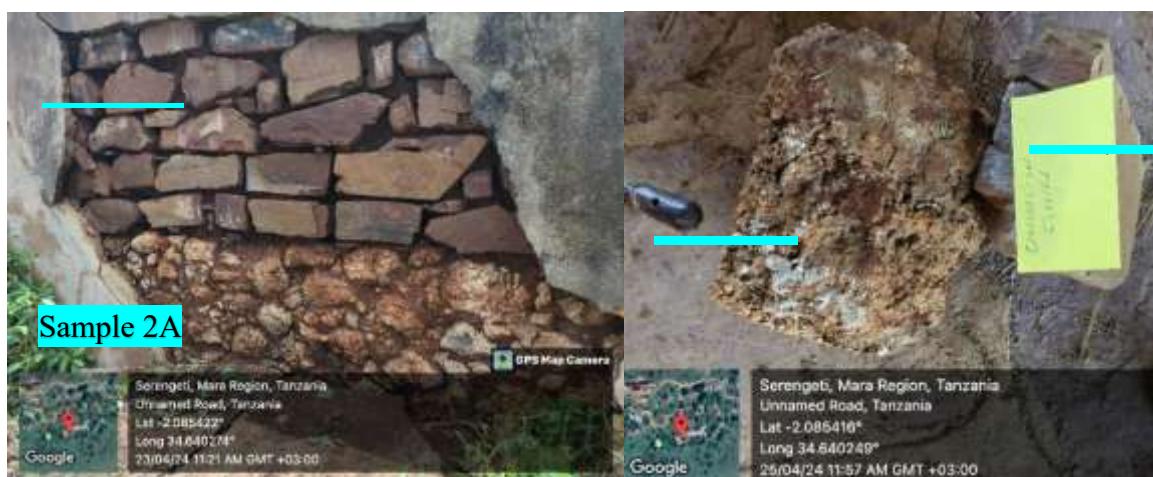
Figure 3: Identification of two different natural stone samples used for the construction of the Fort Ikoma historical building in SENAPA, Tanzania.

Through visual investigations, two types of stone materials were identified (sample 1B and sample 2A) (see Figure 3). These samples were collected from areas without aesthetic value or severely damaged parts. The samples (25 numbers) were derived from the outer and inner layers, the ratio between inner and external leaves, the bed and head joints of the outer layer, and the inner core layer (Amer et al., 2021).

The samples are grey to reddish brown (1B) and light grey (2A) coloured and composed of clay materials, angular to sub-angular silt to sand-sized grains of quartz and feldspars. The samples have a granular texture; their constituent grains are very fine. These samples were weathered and altered. In this case, prolonged weathering and alteration of the silicate-bearing rocks led to the formation of clay-related minerals. The reddish-brown colour of the shale sample is due to the presence of iron oxide and hydroxide-related minerals.

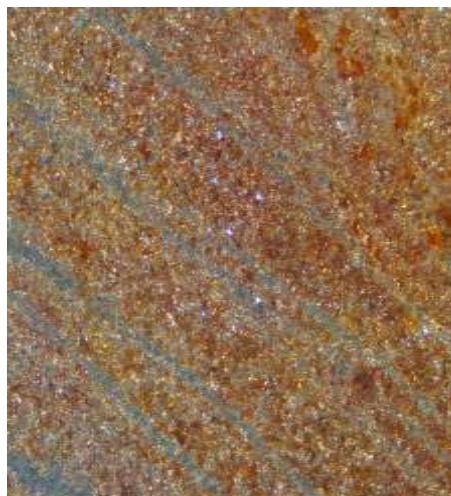
Figure 7: Thin section micrographs of sample 1B.

Thin section micrographs: The thin section micrographs description of sample 1B shown in Figure 7 was;

- i) 1B(a): Colourless, angular to sub-angular excellent quartz crystals. Iron oxide, mainly hematite, fine crystals in the laminated shale.
- ii) 1B(b): Very fine brown biotite crystals with very high pleochroism. Iron oxide (hematite) melt shows a flowing texture surrounding and enclosed in the clay materials (grey with shades).
- iii) 1B(c): Yellowish brown weathered plagioclase and perthitic K-feldspar grains (colourless at PPL and with grey birefringence). Colourless quartz crystals and reddish-brown iron oxide.
- iv) 1B(d): Very fine calcite crystals (with high reflecting colours at the bottom of the micrography), Clay materials (black), oxide, colourless quartz crystals, weathered plagioclase feldspars, and iron oxide.

Descriptions: The rock was fine-grained, fissile (splits into thin pieces along the laminations), and laminated (made up of many thin layers), composed of very fine crystals of silt- and clay-sized crystals of clay minerals, angular to sub-angular grains of quartz, and weathered plagioclase feldspars. The rock was characterized by very fine grains of silt and clay particles and a clastic and splintery texture, which makes this rock easily split into thin plates. The rock was formed where mud, silt, and clay-sized mineral crystals were deposited by slow transporting currents and became compacted at the bottom of water bodies. The presence of iron oxide and hydroxide in this rock, such as hematite, goethite, and limonite, which were observed to be isotropic in the microscope, contributed to the reddish-brown colour of this rock. The rock sample was characterized by having a highly weathered plagioclase feldspar grain (colourless, with grey interference colours). Quartz crystals in this sample were fine, round to sub-round, indicating transportation from a certain distance. The muscovite mica was the high-order-coloured strands and strongly pleochroic with basal to perfect cleavage, with the brown grains being biotite mica. Muscovite was colourless at Plane Polarized Light (PPL) and showed high birefringence at Cross Polarized Light (XPL), while Biotite was brown at PPL. The biotite and muscovite flakes were randomly oriented. The grey and colourless grains were quartz and weathered feldspar. The possible name of the stone/rock was Shale. Shale simply splits into thin, mm-scale flakes along the sedimentary bedding, otherwise known as a shaly fissility. Furthermost shales indicate several kinds of grey, showing a high content of clay combined with small amounts of non-oxidized, ferrous iron-rich minerals. Brown or red shale might contain oxidized ferric iron minerals such as hematite (Fe_2O_3). Organic-rich shales were dark grey or black, whereas pale grey and pale green shales (Merriman et al., 2003).
